123 Frontage Rd.

1A. TermN8 www.termn8.pro
Name of Inspection Company

Diagram of Structure(s) Inspected

Additional Information and Report Summary

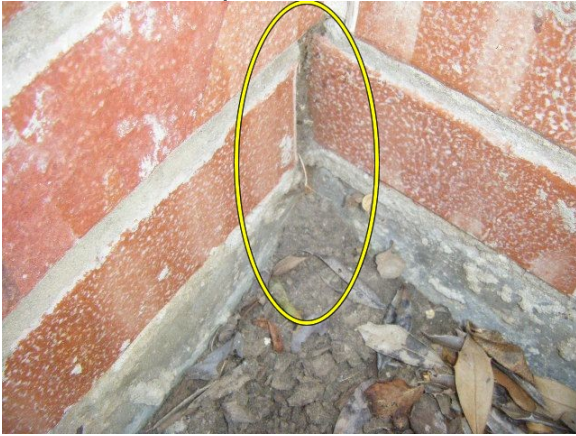
Active termites present in the front exterior corner to the left of the front porch
