123 Frontage Rd.

1A. TermN8 www.termn8.pro
Name of Inspection Company

3. Monday, November 1, 2010
Inspection Date

Diagram of Structure(s) Inspected

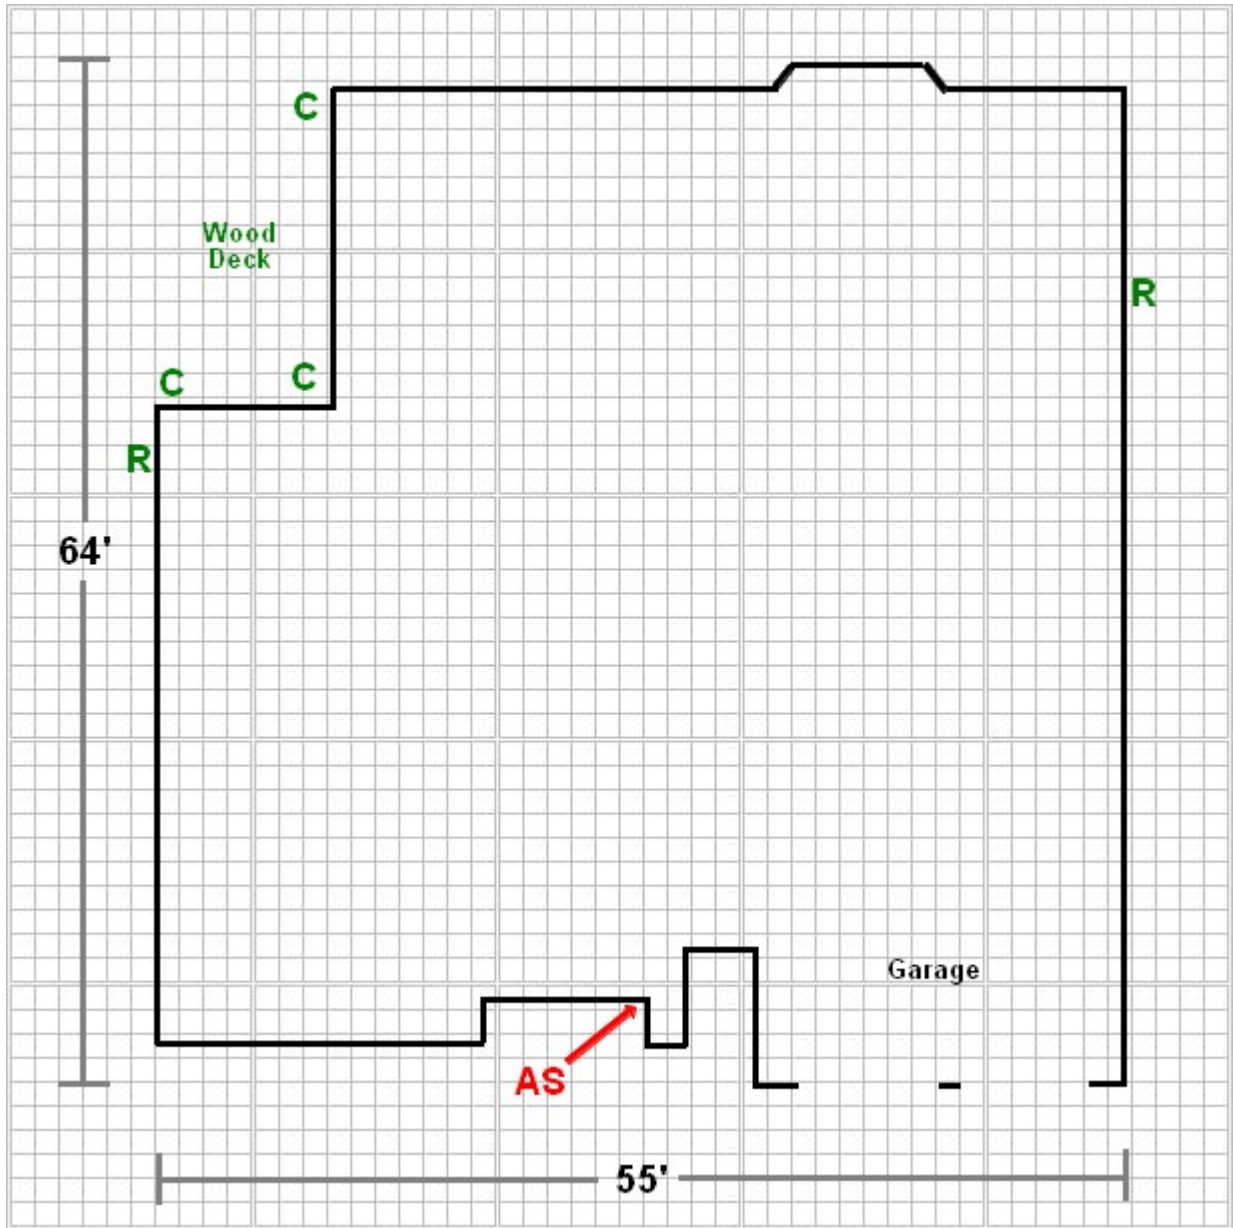
8G. Visible evidence of: Sub termites has been observed in the following areas: Exterior front inside corner to left of front porch (AS)

Specify reason: Wood deck in contact with house and obstructing view to inspect this area (C)

The inspector must draw a diagram including approximate perimeter measurements and indicate active or previous infestation and type of insect by using the following codes: E-Evidence of infestation; A-Active; P-Previous; D-Drywood Termites; S-Subterranean Termites; F-Formosan Termites; C-Conducive Conditions; B-Wood Boring Beetles; H-Carpenter Ants; Other(s) - Specify _____

9B. A preventive treatment and/or correction of conducive conditions as identified in 7A & 7B is recommended as follows: Yes No

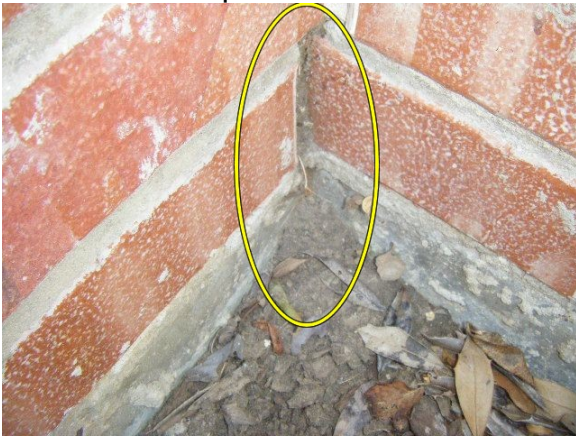
Active termites present in the front exterior corner to the left of the front porch

9A. Corrective treatment recommended for active infestation or evidence of previous infestation with no prior treatment as identified in Section 8. (Refer to Part G, H and I, Scope of Inspection) Yes No
